# Inspection Report

**Property Address:**  
9876 Property Blvd.  
Niles, IL 60714

**RCM Home Inspections, LLC**

<b>Date:</b> 5/6/2005	<b>Time:</b> 09:30 AM	<b>Report ID:</b> Sample 1
<b>Property:</b> 9876 Property Blvd. Niles, IL 60714	<b>Customer:</b> Mr. John Sample Mrs. Jane Sample	<b>Real Estate Professional:</b> John Smith ABC Realty

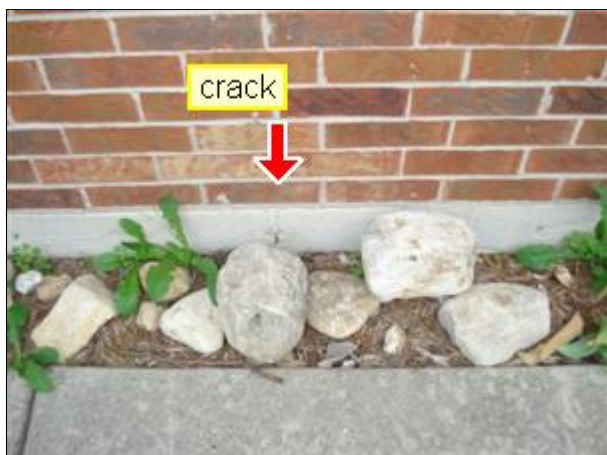
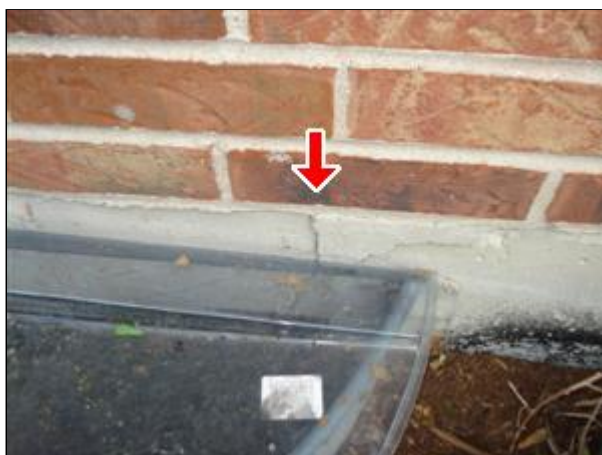
Foundation is older poured concrete with several signs of vertical cracking (Picture 1 & 2 are examples) around perimeter of house and by window wells, probably due to settlement. These cracks appear to have been professionally repaired from inside. No signs of efflorescence or wicking to brick. The some corners of the foundation (Picture 3 & 4 are examples) had small pieces of concrete missing

WL- Recommend that the foundation be monitored for a period of time since crack repairs were recent.

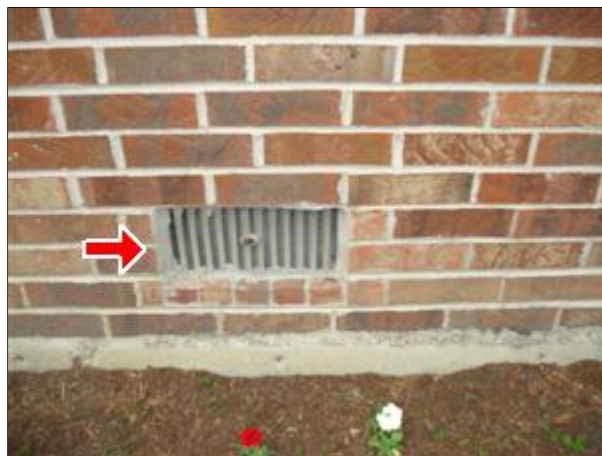
1.0 Picture 5

Crawl space was vented through the brick (Picture 5). Crawl was inspected from opening.

1) WL - Recommend, as an upgrade, that the crawlspace vents be replaced with thermostatic controlled vents. These vents are not expensive and will help to properly ventilate the crawlspace but will automatically close in the winter season.

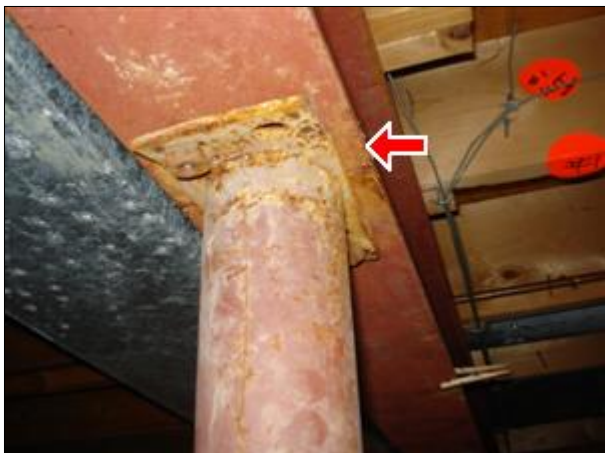
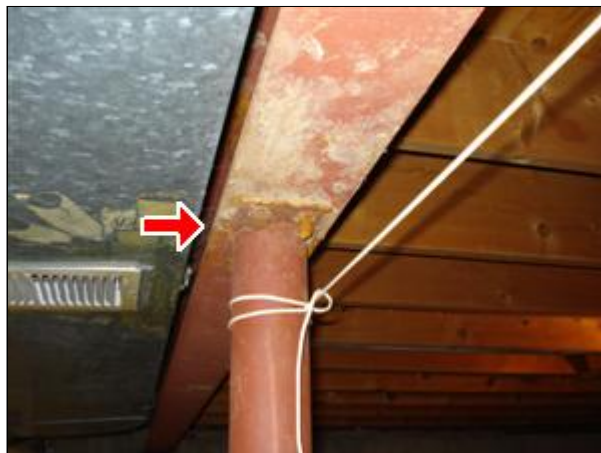
Structure is supported by a centrally running steel girder, running north to south, and supported by steel posts. The girder and post displayed signs of rust with no displacement. The posts are not secured properly to girder since bolts are missing and/or not tightened. This is a safety issue since this is the main support of structure.

SD - Recommend that the missing bolts connecting the metal supporting posts to the steel girders be replaced and all bolts be tightened.

RR - Recommend sealing posts and beams with a rust preventing paint.

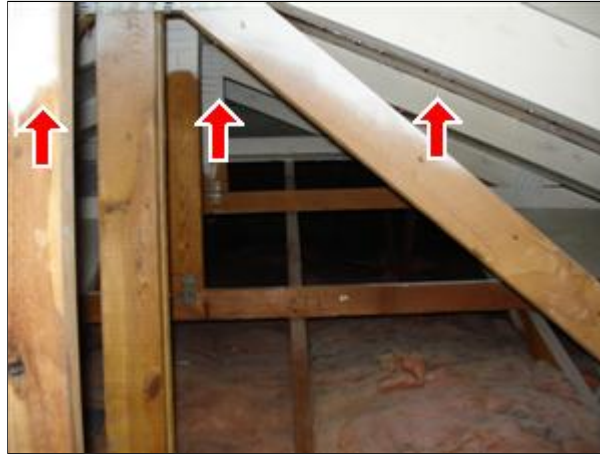
1.7 Picture 1

The area of attic roof deck above master bedroom was coated with a white sealant (Picture 1). Buyer stated that the attic was professionally treated for mold and that he had supporting documents to verify this. No potential biological material was observed.

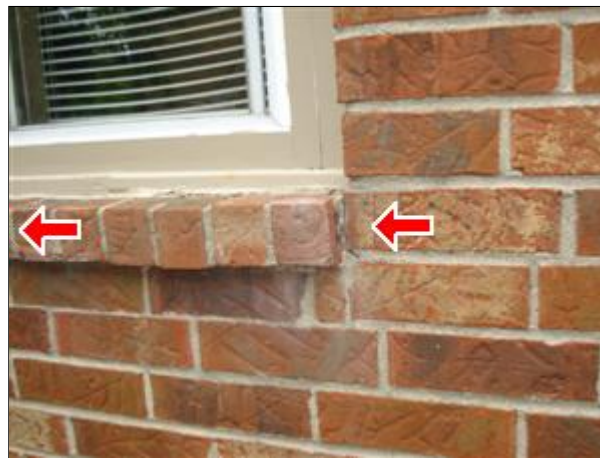
2.0 Picture 1

The brick on the north window sill trim displayed some minor missing mortar ( Picture 1 ) consistent with the age of the house.

RR - Recommend that missing mortar in the brick sills be tuckpointed with mortar as a guard against water intrusion.

This repair can be done by a qualified brick mason.

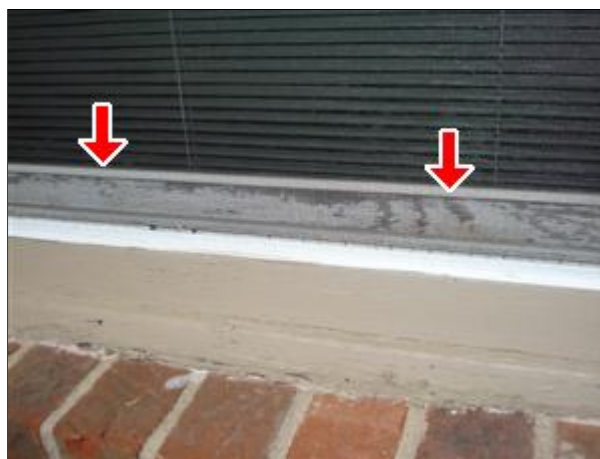
2.4 Picture 1

Exterior windows were wood with metal storm windows and displayed minor signs of peeling paint deterioration . All caulk joints were without signs of deterioration but some caulk was not professionally applied. The wooden window trim was freshly painted without signs of peeling paint and moisture readings of the wood was within normal limits.

RR - recommend that all windows with peeled or deteriorated paint be painted to protect against any damage.

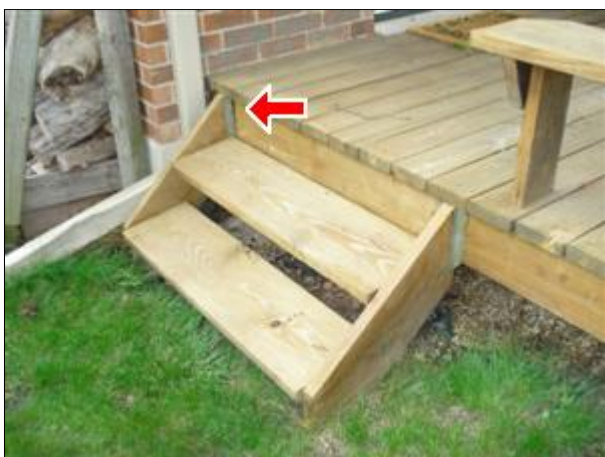
2.7 Picture 1

House was equipped with a low rear deck wood deck. Decking was 2X6 with 2X8 structure. Where visible metal brackets were used to join structure. Access under deck prohibited inspection of attachment to house. Posts were set in concrete. Loose nails were observed on the bracket of the deck stairs (Picture 1). Deck stairs had no railing. Lattice (Picture 6) above deck is not secured

RR - Recommend that deck stairs be re-secured and that since stairs have 3 rises that a railing be added by a qualified carpenter.

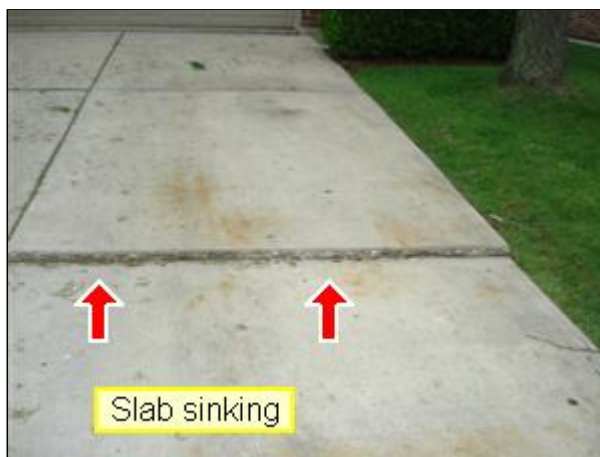
2.7 Picture 2

Concrete driveway appeared to have one slab sinking (Picture 2) with some cracking in other sections (Picture 3).

RR - Recommend that driveway and walks be repaired by a qualified concrete contractor.

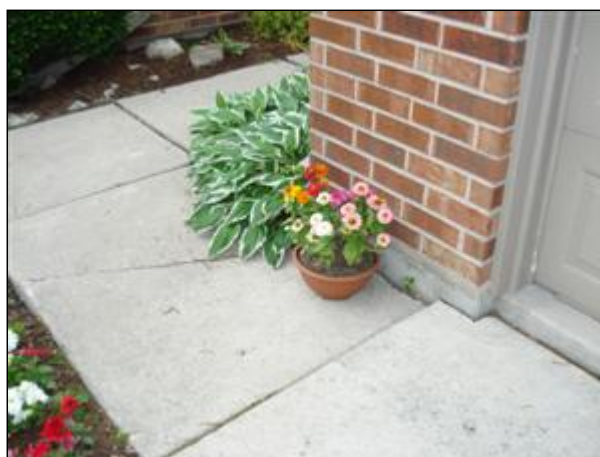
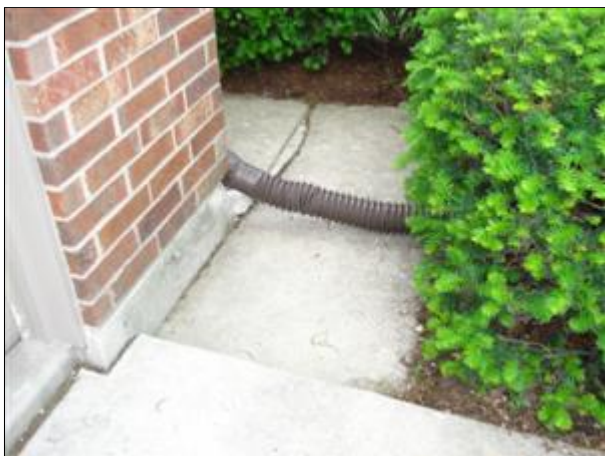
Sidewalks to right and left of garage had cracking and settling (Picture 4-5)

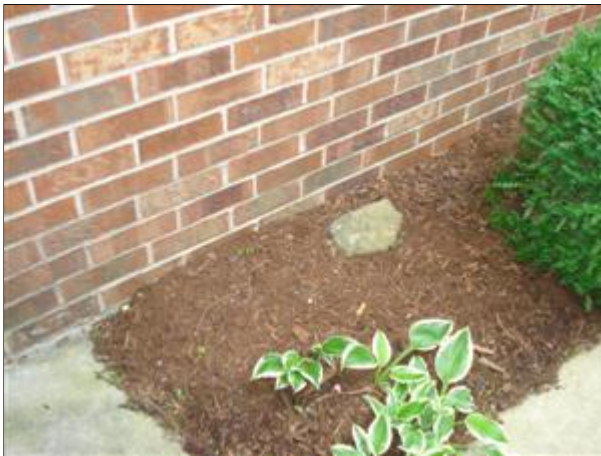
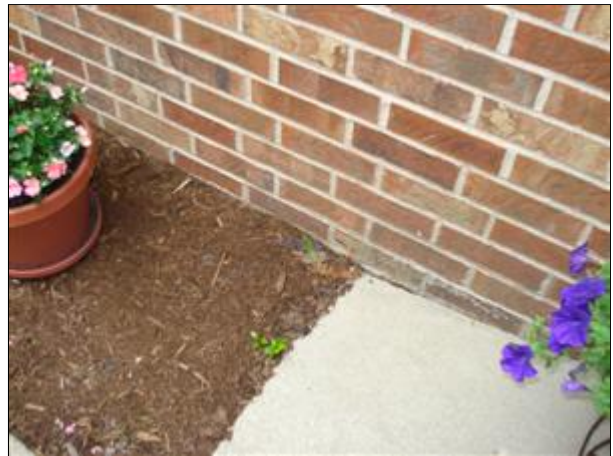
The grading around the house was somewhat high, at the front entry ( Picture 1-2 ). It is recommended, for brick veneer houses, that 4-6" of concrete foundation be exposed above the grade level as a guard against water intrusion.

RR - Recommend lowering grade at front entry to expose 4-6" of foundation.

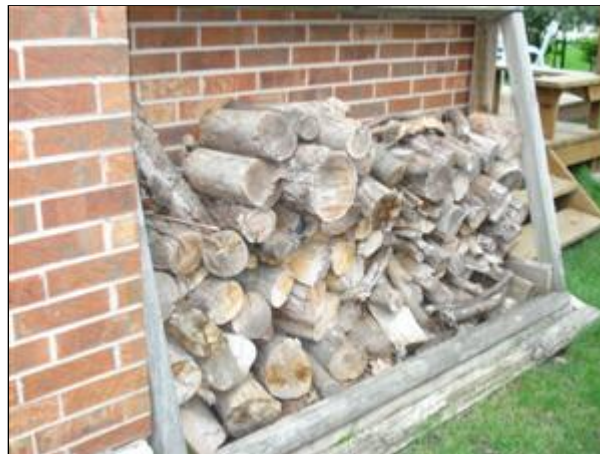
2.10 Picture 5

Log rack was located on south side of house. This is an invitation for pests and insects to be attracted. (Picture 5)

RR - recommend relocation of log rack a minimum of 10' from house.

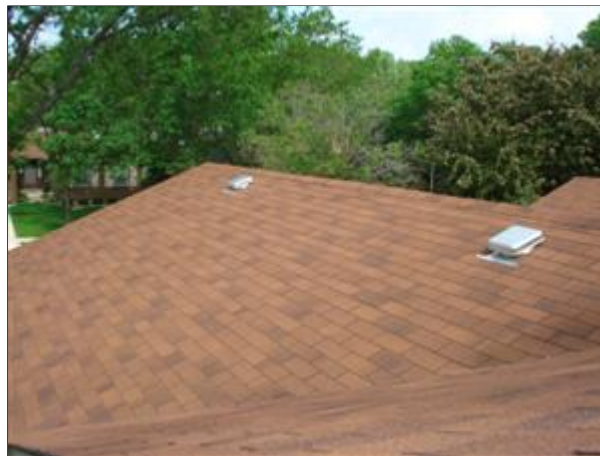
3.0 Picture 1

The roof is covered with newer asphalt impregnated fiberglass shingles in dimensional style. The roof displays no signs of missing shingles, cupping, fishmouth or displacement.

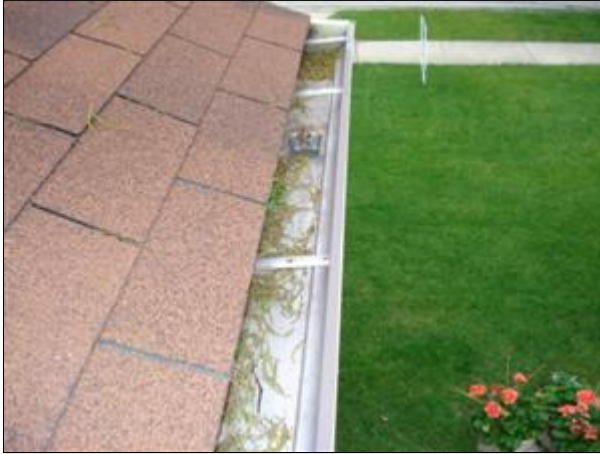
3.3 Picture 1

The roof is drained by means of newer metal gutters that are secured to the fascia boards by means of metal hangers ( Picture 1 ). The spacing of the gutter supports meets the modern standard of a maximum of 18" spacing between supports. The gutters appear to be properly sloped.

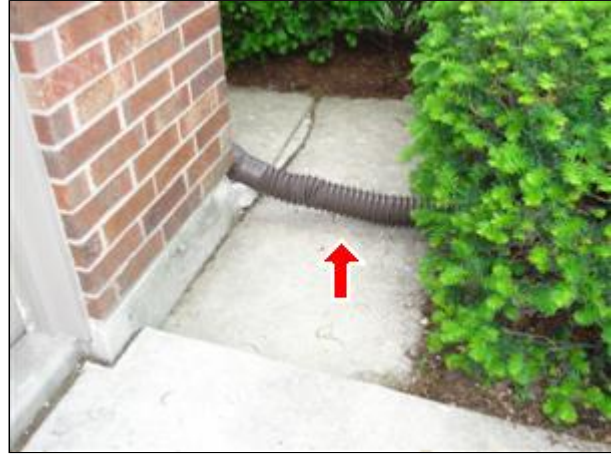
3.3 Picture 2

Downspout extension left of garage crosses the walk causing a trip hazard.

SD - Gutter extensions should extend 6' from structure but should not cross or eject water onto walkways. This is a safety issue since the extension or freezing water can cause tripping.

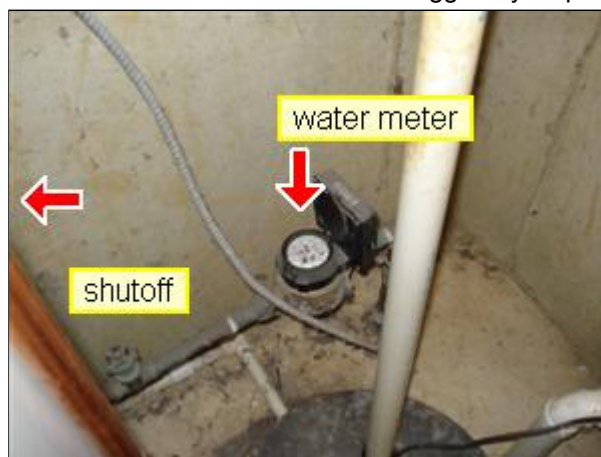
4.4 Picture 1

Main water shut-off was located at the NW corner of the basement ( Picture 1 ). The meter was properly equipped with a ground bonding jumper around the water meter. The shutoff was tagged by inspector.

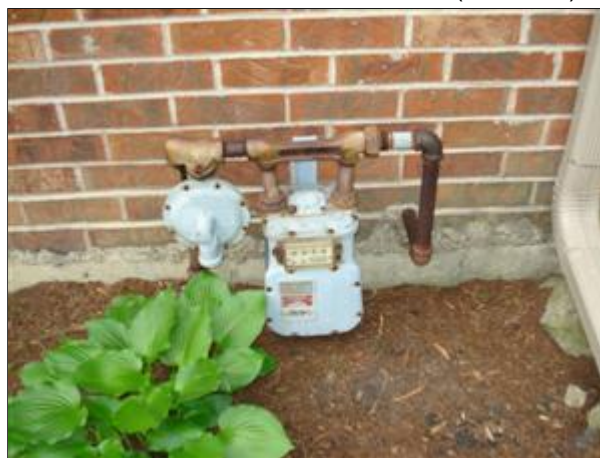
4.5 Picture 1

Natural gas fuel was distributed by means of the proper black pipe. This piping was tested for leaks at the furnace, water heater, and clothes dryer and none were found. Range had no access behind it to test for leaks. There was no main gas shut off in house. Meter was located on the north outside wall (Picture 1).

1) RR - Recommend the installation of main gas shutoff inside of the basement so gas can be turned off from inside. Turning gas off from outside can be difficult with snow and icing conditions.

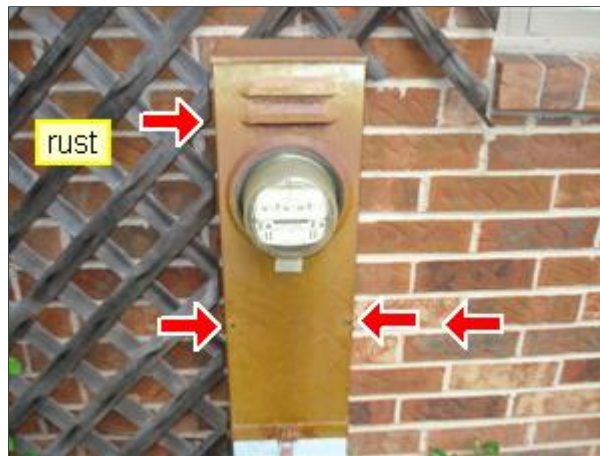
5.0 Picture 1

Electrical service is supplied by means of an underground (lateral) service drop from the utility pole to the meter box located back of the house (Picture 1). The meter was rated for 200 amp service.

Cabinet was beginning to rust and had 2 screws missing.

RR - Recommend that electric service provider inspect this cabinet and replace missing screws.

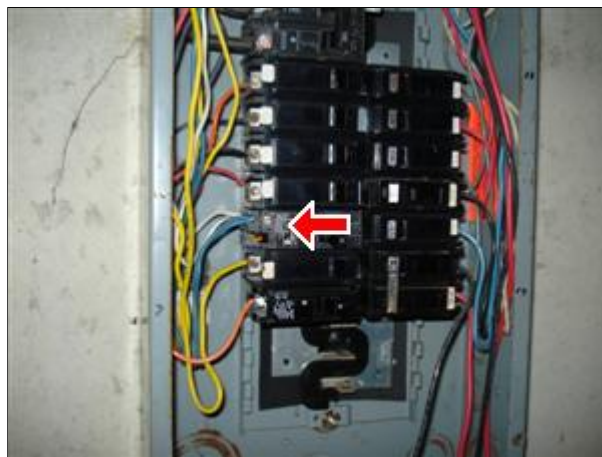
5.3 Picture 1

All overcurrent devices (circuit breakers) appear to be the proper type and appear to be served by the correct gauge wire for their rated amperage. There was one double tap on circuit #5. All neutral conductors are properly seated in the neutral bus and the neutral bus is properly bonded to the panel and the ground.

RR - Recommend removal of double tap to circuit breaker #5 by a licensed electrician

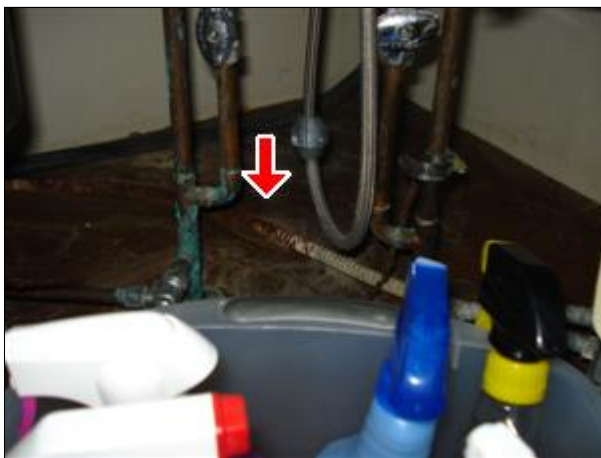
5.5 Picture 3

The dish washer power was supplied under the kitchen sink by armored cable that was rusted and deteriorating (Picture 3)

RR - Recommend repair/replacement of the rusted armored cable that supplies the dishwasher. This should be done by a licensed electrician.

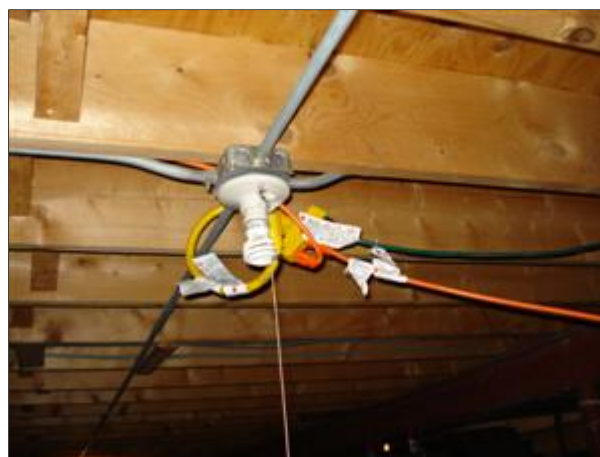
5.5 Picture 5

Extension cord was used to supply TV in basement.(Picture 5)

RR - Recommend use of extension cords are temporary and should be removed after use.

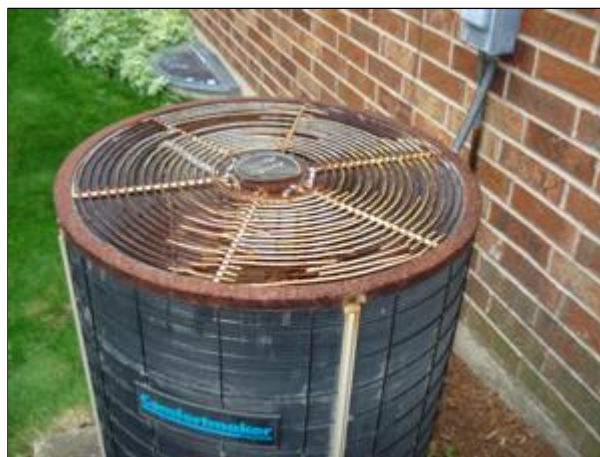
7.0 Picture 1

Air conditioner compressor was an older Comfort Maker unit. Its model and serial number and serial number could not be located to verify age or recalls. The top of unit was rusted .

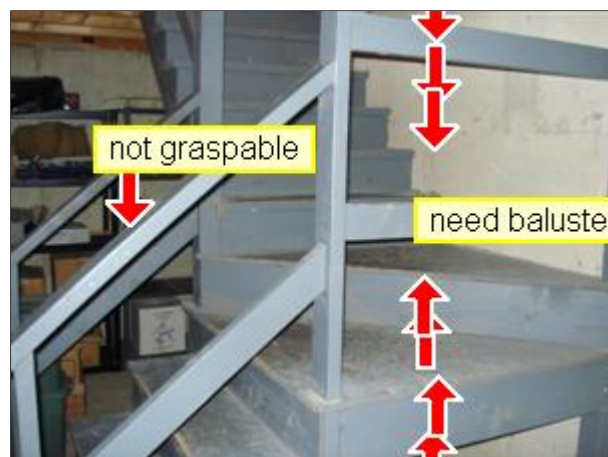
8.3 Picture 1

Basement stairs are tight and secure. The basement stairway is not equipped with balusters. 2X4 Hand rail at lower portion was not sufficiently graspable.

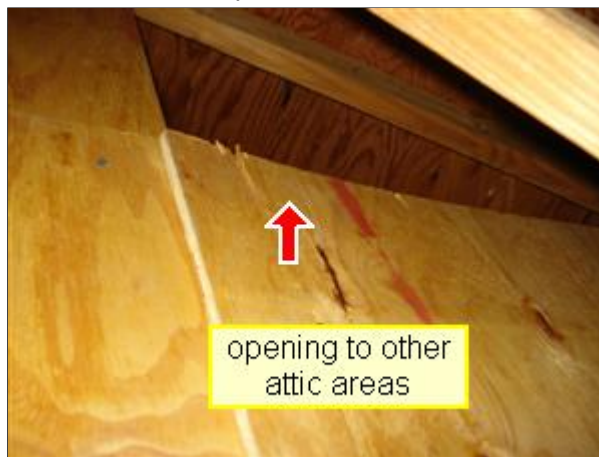
9.0 Picture 1

The attic insulation varied by three locations that were observed through three hatches that entered one common attic area. The above-the-garage attic area was partially blocked by a plywood wall (Picture 1) but had large openings to the remaining attic. The garage ceiling had drywall missing creating a direct opening to that attic. None of the hatches were insulated. There was no insulation (R0) above attached garage. There was approximately 4-6" (R18-24) of fiberglass batt/roll insulation above master bedroom. There was approximately 8-10" (R24-30) fiberglass batt/roll insulation above living, kitchen, dinning rooms. Some vapor barrier was seen. The rim joists in the basement were not insulated with fiberglass batts. Wall insulation was not visible for inspection.

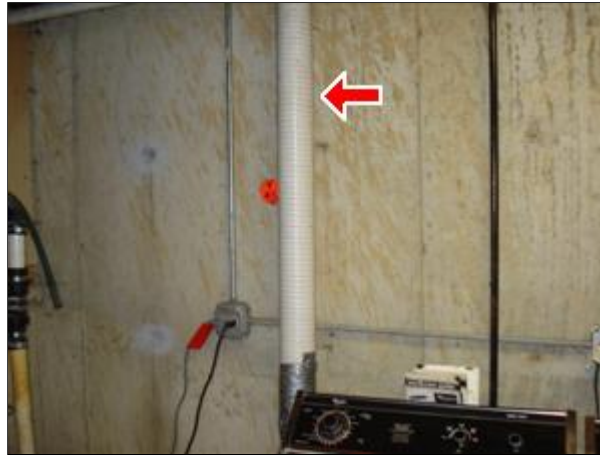
9.2 Picture 1

It should be noted that the clothes dryer vent (Picture 1) was vented by means of a vinyl vent hose. There have been many reports of fires caused by the use of vinyl vent hoses due to their flammable characteristics. This is a safety issue.
