# Inspection Report

**Property Address:**  
9876 Property Blvd.  
Niles, IL 60714

**RCM Home Inspections, LLC**

<b>Date:</b> 5/6/2005	<b>Time:</b> 09:30 AM	<b>Report ID:</b> Sample 1
<b>Property:</b> 9876 Property Blvd. Niles, IL 60714	<b>Customer:</b> Mr. John Sample Mrs. Jane Sample	<b>Real Estate Professional:</b> John Smith ABC Realty

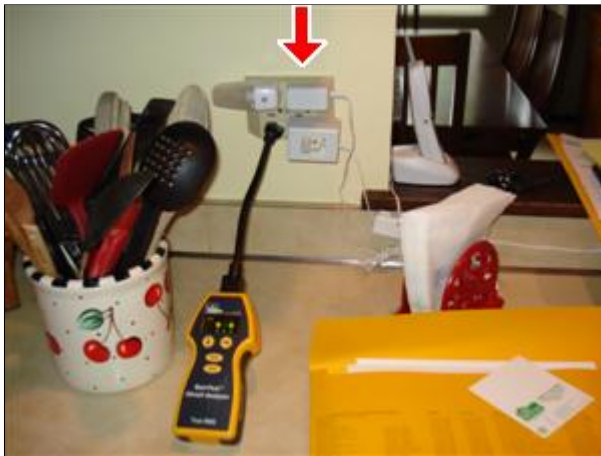
5.5 Picture 1

The east kitchen counter receptacle is not grounded and had a multiplier attached (Picture 1). The opposite wall baseboard receptacles was also not grounded (Picture 2).
